**Flood Control Project Maintenance
Levee Inspections**

Maintenance Issue Types Only, Levee Inspection Report By Mile - Spring 2019

Reclamation District No. 0551 Pearson

Waterway	Bank	Unit Miles	Inspection Start/End	Inspector
Unit No. 01 Sacramento River	Left	6.78	03/15/2019 03/15/2019	David Julian

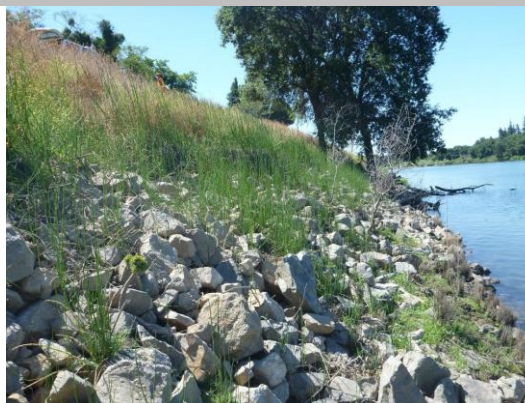
Photo 1 of 3 : SP_2019_RD0551_175_18_20190311_00002.jpg

Comment Code					
Inspector Comment					
Levee Evaluation Comments					
Description:District Station 84+15 to 87+60, Sec. 06, T. 5 N. R. 4 E., M.D.M. Approximately 135 linear-feet of erosion/sloughing exists along the waterside levee slope of the Sacramento River. Sloughing commences approximately 3/4 of the way down the slope from the crown and extends into the rip rap. Some existing rip rap has been pulled off in this section.					
Site ID No:331					
Site Designation:LMA-158					
Repair Type: Erosion					
Rating:Area of Concern					
Field Date:7/13/2017					
Notes: thorney veg on upper slope, light veg within rip rap. Crown is a paved road. 1 ft vertical scarp max just above rip rap so we rated it as a lower priority.

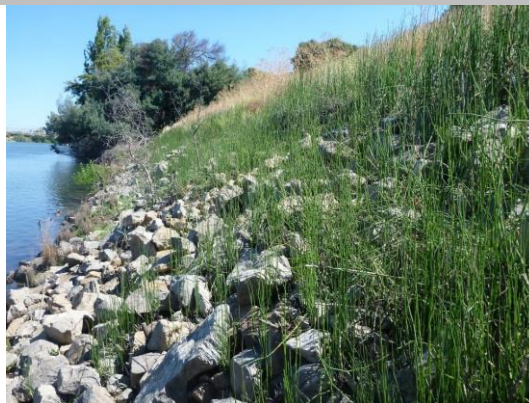
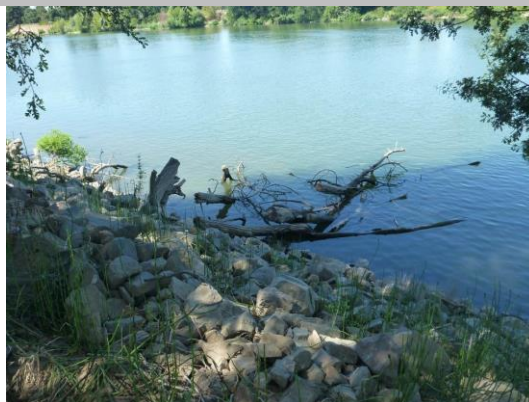
Comment Code						
Inspector Comment						
Levee Evaluation Comments						
Description:District Station 84+15 to 87+60, Sec. 06, T. 5 N. R. 4 E., M.D.M. Approximately 135 linear-feet of erosion/sloughing exists along the waterside levee slope of the Sacramento River. Sloughing commences approximately 3/4 of the way down the slope from the crown and extends into the rip rap. Some existing rip rap has been pulled off in this section.						
Site ID No:331						
Site Designation:LMA-158						
Repair Type: Erosion						
Rating:Area of Concern						
Field Date:7/13/2017						
Notes: thorney veg on upper slope, light veg within rip rap. Crown is a paved road. 1 ft vertical scarp max just above rip rap so we rated it as a lower priority.

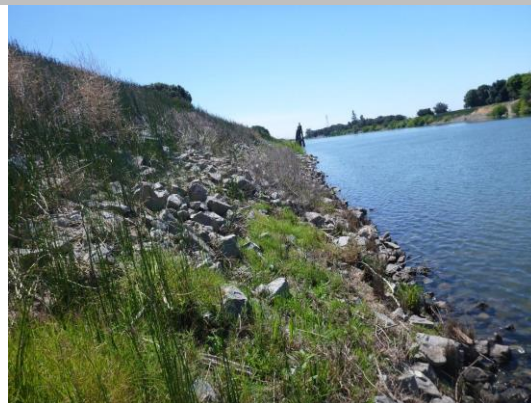
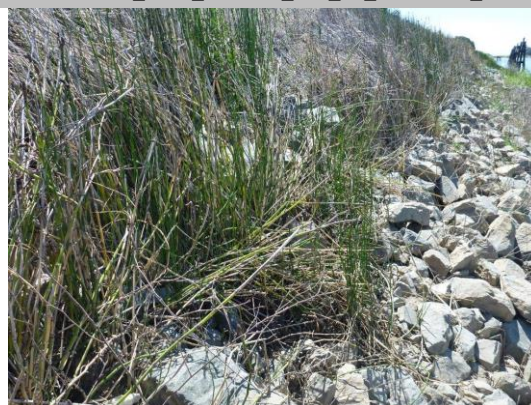
LM Start	2.71	Rating **	A/W	Issue No.	22
LM End	2.74	Issue Type +	Ma	Location *	
Category	Supplemental			GPS Latitude/Longitude	
				Start	End
Item	2017 Storm Damage			38.301258 °	38.300922 °
				-121.569550 °	-121.569258 °
DWR ID	DWR_RD0551_01_f_2017_22				
Comment Code					
Inspector Comment					
Levee Evaluation Comments					
Description:District Station 142+31 to 143+80, Sec. 08, T. 5 N. R. 4 E., M.D.M. Approximately 149 linear-feet of erosion exists along the waterside slope of the Sacramento River. The erosion exists near the rip rap line about 3/4 of the way down the slope. Some existing rip rap has been pulled off in this section.					
Site ID No:332					
Site Designation:LMA-159					
Repair Type: Erosion					
Rating:Area of Concern					
Field Date:7/13/2017					
Notes: Crown is a paved road. Minor errosion right above and in the top of the rip rap.

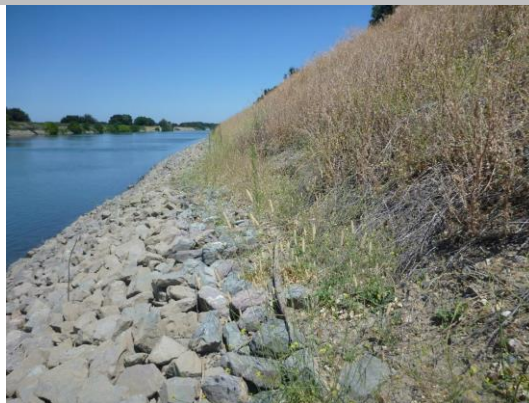
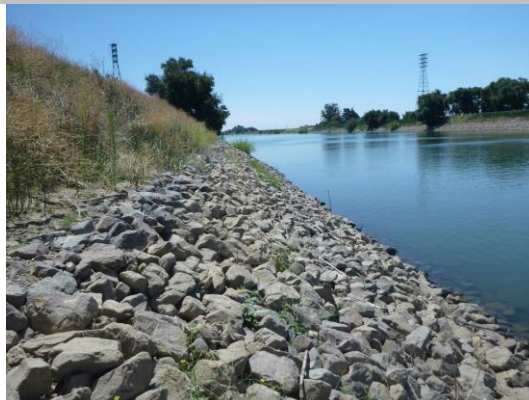
Comment Code						
Inspector Comment						
Levee Evaluation Comments						
Description:District Station 159+69 to 170+73, Sec. 08, T. 5 N. R. 4 E., M.D.M. Approximately 1,104 linear-feet of erosion and subsequent sloughing exists along the waterside slope of the Sacramento River. The erosion commences approximately halfway down the slope to the rip rap line.						
Site ID No:333						
Site Designation:LMA-160						
Repair Type: Erosion						
Rating:Area of Concern						
Field Date:7/13/2017						
Notes: Crown is a paved road. Thorny veg on upper slope, none in rip rap. Scarps upto 3 ft, mostly smaller, above rip rap. Area of concern because erosion is not too deep into prism and good rip rap protection on lower slope.

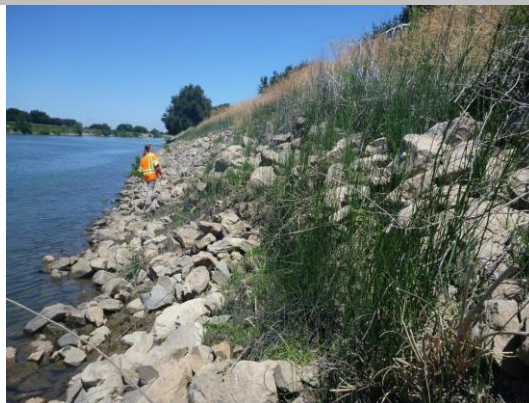
Photo 3 of 3 : SP_2019_RD0551_175_27_20190311_00020.jpg

Comment Code					
Inspector Comment					
<p>Levee Evaluation Comments</p> <p>Description: District Station 175+36 to 176+30, Sec. 08, T. 5 N. R. 4 E., M.D.M. Approximately 94 linear-feet of erosion exists along the waterside slope of the Sacramento River. The erosion occurs within the rip rap area near the waterline. Sloughing is exhibited in the in the bottom half of the slope. Some existing rip rap has been pulled off in this section.</p> <p>Site ID No: 334</p> <p>Site Designation: LMA-161</p> <p>Repair Type: Erosion</p> <p>Rating: Area of Concern</p> <p>Field Date: 7/13/2017</p> <p>Notes: Crown is a paved road. Scarps upto 3 ft within rip rap and 18 in above rip rap. Lower priority because erosion does not significantly cut into prism and damage was not continuous through whole site.</p>

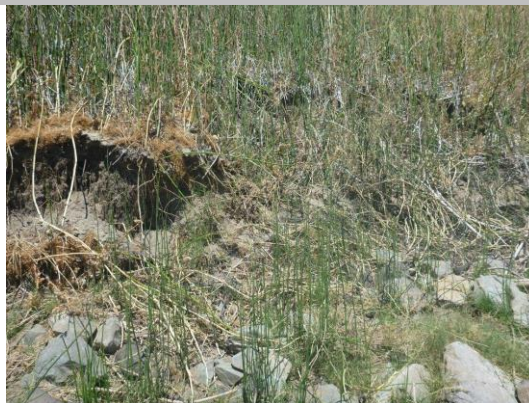
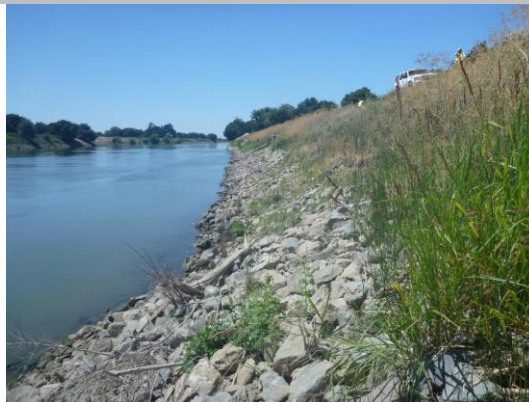
Comment Code						
Inspector Comment						
Levee Evaluation Comments						
Description:District Station 235+90 to 237+83, Sec. 16, T. 5 N. R. 4 E., M.D.M. Approximately 193 linear-feet of erosion exists along the waterside slope of the Sacramento River. The erosion commences approximately halfway down the slope and extends to the rip rap. Some existing rip rap has been pulled off in this section.						
Site ID No:337						
Site Designation:LMA-164						
Repair Type: Erosion						
Rating:Area of Concern						
Field Date:7/13/2017						
Notes: Crown is paved road. Veg on slope, not lower bank. Scarps up to 18 in deep above rip rap. Lower priority because erosion is fairly small and rip rap is in good shape through most of the site.

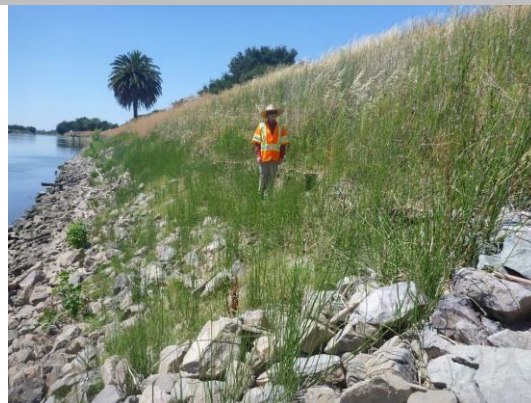
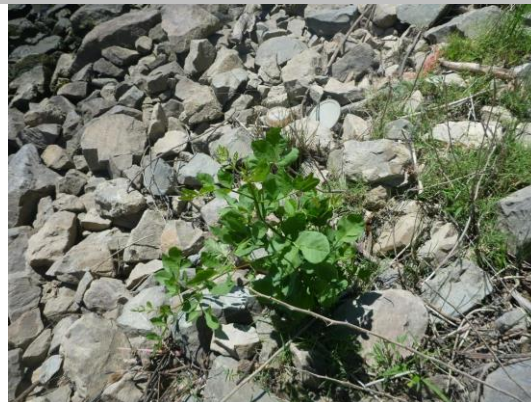
Comment Code					
Inspector Comment					
Levee Evaluation Comments					
Description:District Station 245+47 to 247+26, Sec. 16, T. 5 N. R. 4 E., M.D.M. Approximately 179 linear-feet of erosion and sloughing exists along the waterside slope of the Sacramento River. The erosion commences approximately halfway down the slope and extends to the rip rap. Some existing rip rap has been pulled off in this section.					
Site ID No:338					
Site Designation:LMA-165					
Repair Type: Erosion					
Rating:Area of Concern					
Field Date:7/13/2017					
Notes: Crown is paved road. Scarps up to 7 ft deep, 2 ft typical above the rip rap. Area of concern because the deeper scarp only covered a short distance and was already vegetated so not actively eroding.

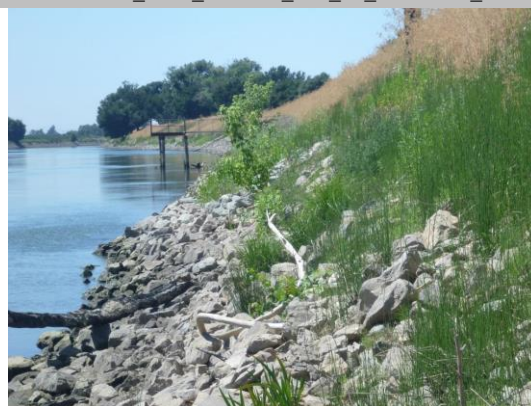
Photo 3 of 3 : SP_2019_RD0551_175_30_20190311_00029.jpg

Comment Code					
Inspector Comment					
<p>Levee Evaluation Comments</p> <p>Description: District Station 245+47 to 247+26, Sec. 16, T. 5 N. R. 4 E., M.D.M. Approximately 179 linear-feet of erosion and sloughing exists along the waterside slope of the Sacramento River. The erosion commences approximately halfway down the slope and extends to the rip rap. Some existing rip rap has been pulled off in this section.</p> <p>Site ID No: 338</p> <p>Site Designation: LMA-165</p> <p>Repair Type: Erosion</p> <p>Rating: Area of Concern</p> <p>Field Date: 7/13/2017</p> <p>Notes: Crown is paved road. Scarps up to 7 ft deep, 2 ft typical above the rip rap. Area of concern because the deeper scarp only covered a short distance and was already vegetated so not actively eroding.</p>

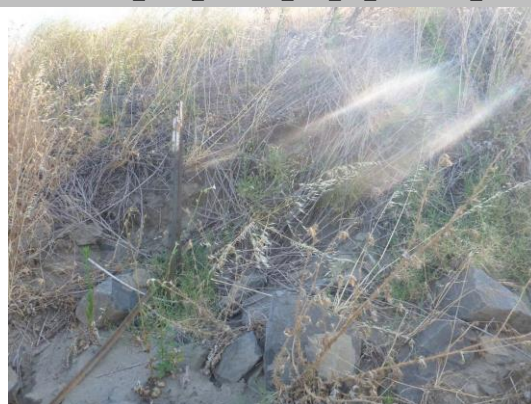
Photo 1 of 3 : SP_2019_RD0551_175_31_20190311_00030.jpg

Comment Code					
Inspector Comment					
<p>Levee Evaluation Comments</p> <p>Description: District Station 258+80 to 260+40, Sec. 16, T. 5 N. R. 4 E., M.D.M. Approximately 160 linear-feet of erosion exists along the waterside slope of the Sacramento River. The erosion commences approximately halfway down the slope from the crown and extends to the rip rap. Some existing rip rap has been pulled off in this section.</p> <p>Site ID No: 339</p> <p>Site Designation: LMA-166</p> <p>Repair Type: Erosion</p> <p>Rating: Area of Concern</p> <p>Field Date: 7/14/2017</p> <p>Notes: crown is a paved road. Scarps of 2.5 ft just above rip rap. Area of concern because erosion is fairly small.</p>

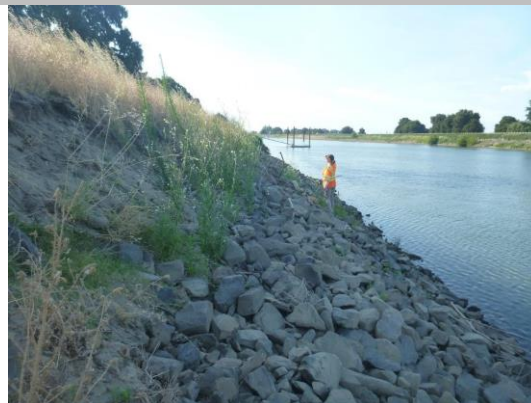
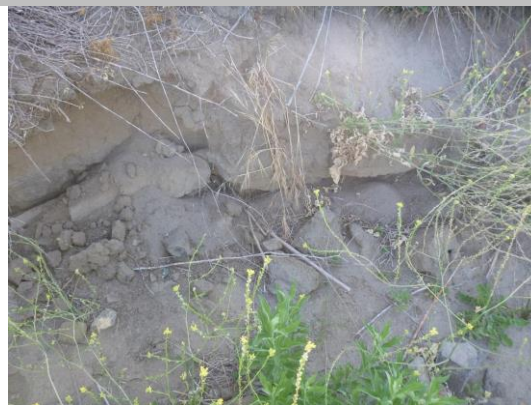
Comment Code						
Inspector Comment						
Levee Evaluation Comments						
Description:District Station 258+80 to 260+40, Sec. 16, T. 5 N. R. 4 E., M.D.M. Approximately 160 linear-feet of erosion exists along the waterside slope of the Sacramento River. The erosion commences approximately halfway down the slope from the crown and extends to the rip rap. Some existing rip rap has been pulled off in this section.						
Site ID No:339						
Site Designation:LMA-166						
Repair Type: Erosion						
Rating:Area of Concern						
Field Date:7/14/2017						
Notes: crown is a paved road. Scarps of 2.5 ft just above rip rap. Area of concern because erosion is fairly small.

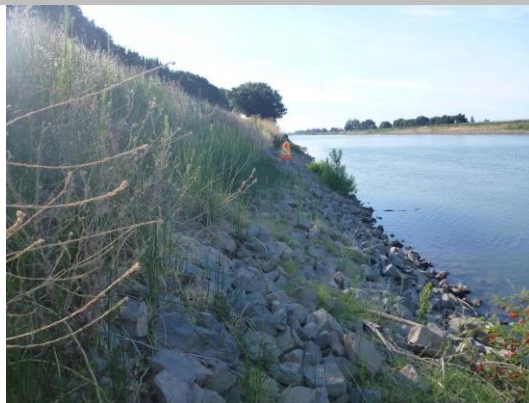
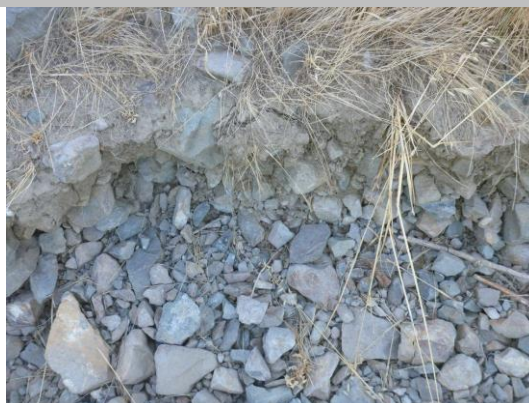
Inspector Comment					
<p>Levee Evaluation Comments</p> <p>Description: District Station 266+16 to 267+71, Sec. 21, T. 5 N. R. 4 E., M.D.M. Approximately 155 linear-feet of erosion and sloughing exists along the waterside slope of the Sacramento River. The erosion commences approximately 3/4 of the way down the slope from the crown and extends into the rip rap. Some existing rip rap has been pulled off in this section.</p> <p>Site ID No: 340</p> <p>Site Designation: LMA-167</p> <p>Repair Type: Erosion</p> <p>Rating: Area of Concern</p> <p>Field Date: 7/14/2017</p> <p>Notes: Crown is a paved road. There is a private boat dock in the middle of the site. Some exposed filter fabric. On the upstream side erosion is above the rip rap and on the downstream side it is within the rip rap. Scarps are 2-3 ft deep. Area of concern because erosion is not very deep into prism.</p>

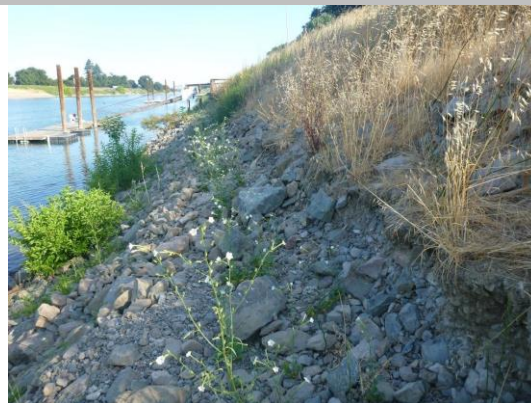
Photo 3 of 3 : SP_2019_RD0551_175_32_20190311_00035.jpg

Comment Code					
Inspector Comment					
<p>Levee Evaluation Comments</p> <p>Description: District Station 266+16 to 267+71, Sec. 21, T. 5 N. R. 4 E., M.D.M. Approximately 155 linear-feet of erosion and sloughing exists along the waterside slope of the Sacramento River. The erosion commences approximately 3/4 of the way down the slope from the crown and extends into the rip rap. Some existing rip rap has been pulled off in this section.</p> <p>Site ID No: 340</p> <p>Site Designation: LMA-167</p> <p>Repair Type: Erosion</p> <p>Rating: Area of Concern</p> <p>Field Date: 7/14/2017</p> <p>Notes: Crown is a paved road. There is a private boat dock in the middle of the site. Some exposed filter fabric. On the upstream side erosion is above the rip rap and on the downstream side it is within the rip rap. Scarps are 2-3 ft deep. Area of concern because erosion is not very deep into prism.</p>

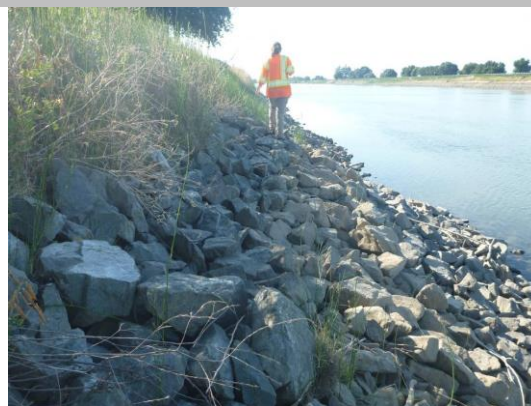
Photo 1 of 3 : SP_2019_RD0551_175_33_20190311_00036.jpg

Comment Code					
Inspector Comment					
<p>Levee Evaluation Comments</p> <p>Description: District Station 269+37 to 271+66, Sec. 21, T. 5 N. R. 4 E., M.D.M. Approximately 229 linear-feet of erosion and sloughing exists along the waterside slope of the Sacramento River. The erosion commences approximately 3/4 of the way down the slope from the crown and extends to the rip rap.</p> <p>Site ID No: 341</p> <p>Site Designation: LMA-168</p> <p>Repair Type: Erosion</p> <p>Rating: Area of Concern</p> <p>Field Date: 7/14/2017</p> <p>Notes: crown is a paved road. Scarps upto 4-5 ft, but 18 inches for most of the length. Large tree within site. Area of concern because deeper erosion is only present for a short distance.</p>

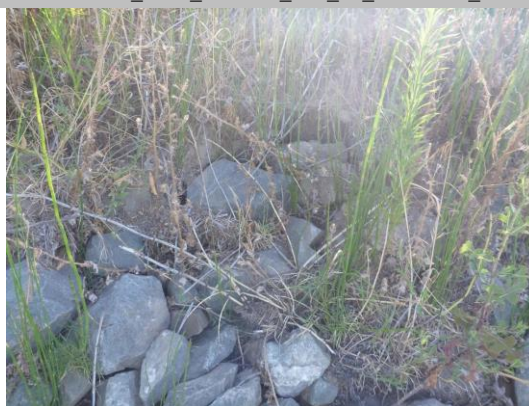
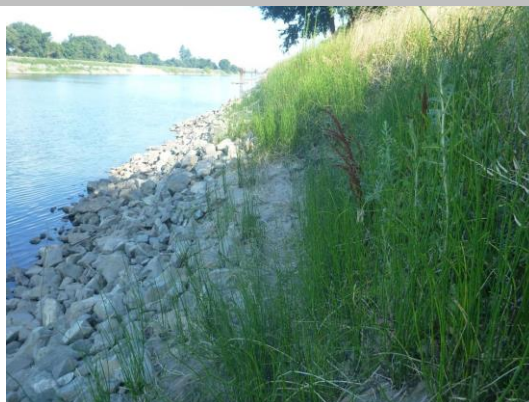
Comment Code						
Inspector Comment						
Levee Evaluation Comments						
Description:District Station 269+37 to 271+66, Sec. 21, T. 5 N. R. 4 E., M.D.M. Approximately 229 linear-feet of erosion and sloughing exists along the waterside slope of the Sacramento River. The erosion commences approximately 3/4 of the way down the slope from the crown and extends to the rip rap.						
Site ID No:341						
Site Designation:LMA-168						
Repair Type: Erosion						
Rating:Area of Concern						
Field Date:7/14/2017						
Notes: crown is a paved road. Scarps upto 4-5 ft, but 18 inches for most of the length. Large tree within site. Area of concern because deeper erosion is only present for a short distance.

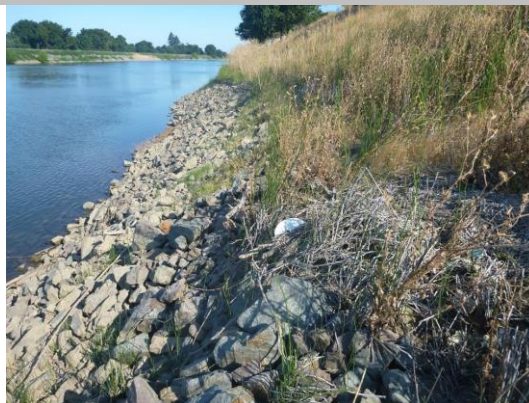
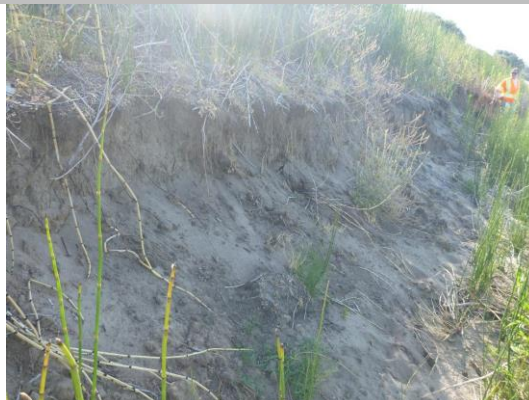
Comment Code					
Inspector Comment					
<p>Levee Evaluation Comments</p> <p>Description: District Station 273+82 to 278+08, Sec. 21 and 22, T. 5 N. R. 4 E., M.D.M. Approximately 426 linear-feet of erosion exists along the waterside slope of the Sacramento River. The erosion commences approximately halfway down the slope and extends to the rip rap. Some existing rip rap has been pulled off in this section.</p> <p>Site ID No: 342</p> <p>Site Designation: LMA-169</p> <p>Repair Type: Erosion</p> <p>Rating: Serious</p> <p>Field Date: 7/14/2017</p> <p>Notes: there is a 7 ft scarp that extends for 40-60 ft in very sandy soil, scarps are 2-4 ft the rest of the length. Worst site in this RD so far. Serious because of the length of this deeper scarp and the weak soil here. Crown is a paved road.</p>

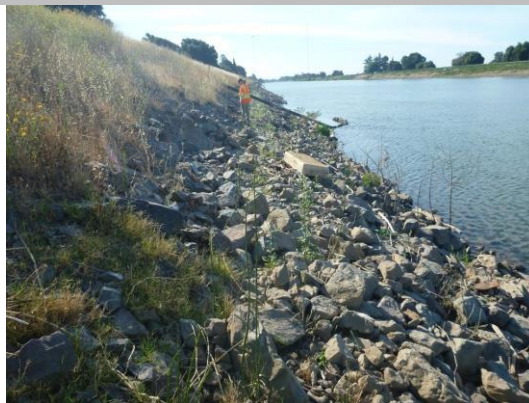
Photo 3 of 3 : SP_2019_RD0551_175_34_20190311_00041.jpg

Comment Code					
Inspector Comment					
<p>Levee Evaluation Comments</p> <p>Description: District Station 273+82 to 278+08, Sec. 21 and 22, T. 5 N. R. 4 E., M.D.M. Approximately 426 linear-feet of erosion exists along the waterside slope of the Sacramento River. The erosion commences approximately halfway down the slope and extends to the rip rap. Some existing rip rap has been pulled off in this section.</p> <p>Site ID No: 342</p> <p>Site Designation: LMA-169</p> <p>Repair Type: Erosion</p> <p>Rating: Serious</p> <p>Field Date: 7/14/2017</p> <p>Notes: there is a 7 ft scarp that extends for 40-60 ft in very sandy soil, scarps are 2-4 ft the rest of the length. Worst site in this RD so far. Serious because of the length of this deeper scarp and the weak soil here. Crown is a paved road.</p>

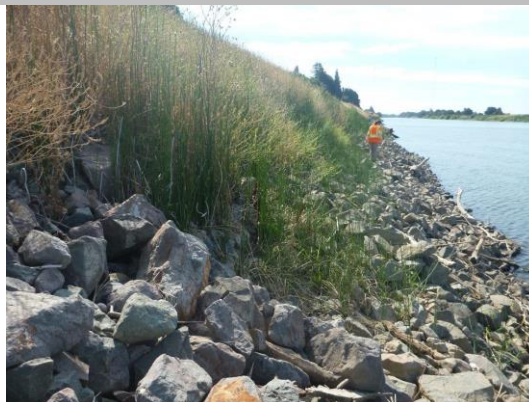
Photo 1 of 3 : SP_2019_RD0551_175_35_20190311_00042.jpg

Comment Code					
Inspector Comment					
<p>Levee Evaluation Comments</p> <p>Description: District Station 283+08 to 285+49, Sec. 22, T. 5 N. R. 4 E., M.D.M. Approximately 241 linear-feet of erosion and sloughing exists along the waterside slope of the Sacramento River. The erosion commences approximately 3/4 of the way down the slope and extends to the rip rap. Some existing rip rap has been pulled off in this section.</p> <p>Site ID No: 343</p> <p>Site Designation: LMA-170</p> <p>Repair Type: Erosion</p> <p>Rating: Area of Concern</p> <p>Field Date: 7/14/2017</p> <p>Notes: Crown is a paved road. Scarps above rip rap 2-4 ft deep, but not continuous through whole site. Area of concern because erosion is not very deep into prism and is not continuous throughout site.</p>
